Abstract of information provided to JCESA Board on January 13, 2021.

I. Summary

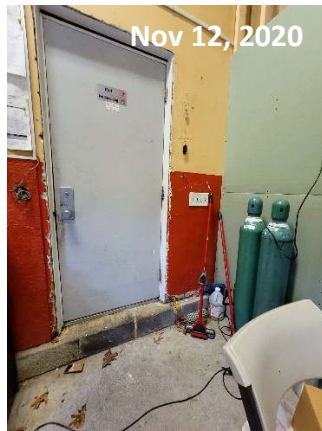
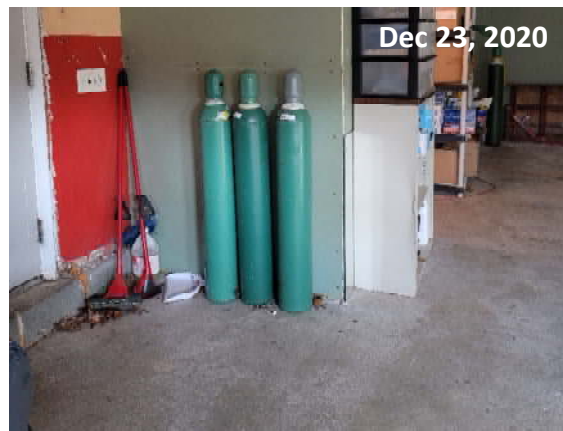
Attachment B

Oxygen tanks not secured. Photos taken November 12, 2020 and December 23, 2020.

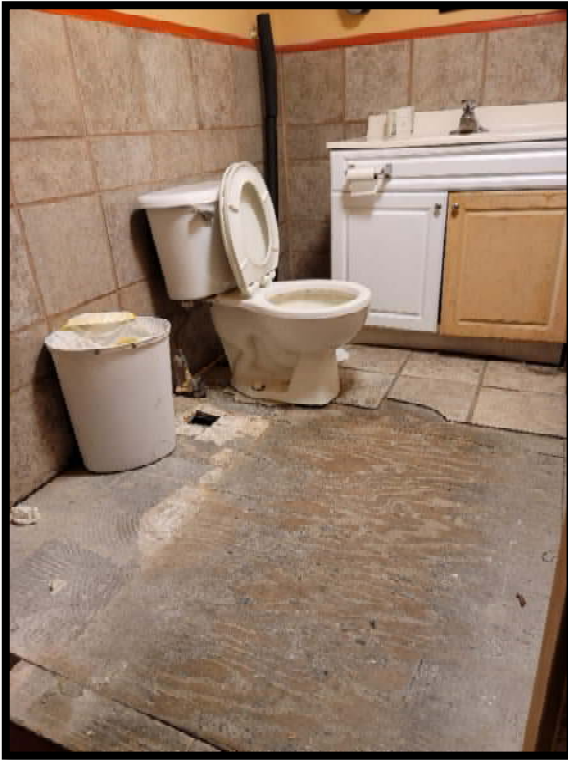
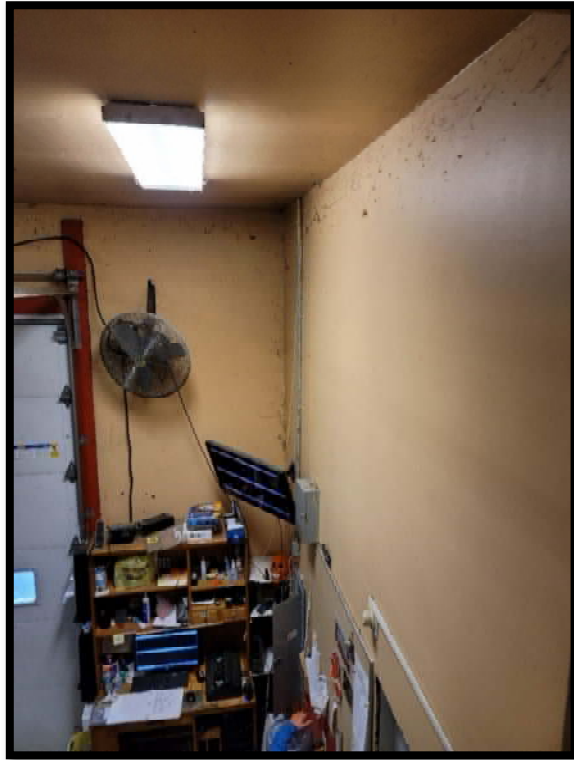
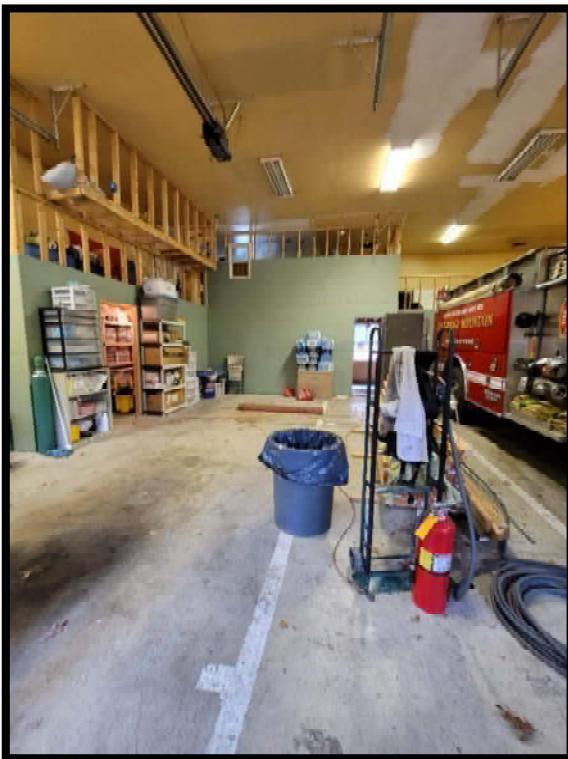
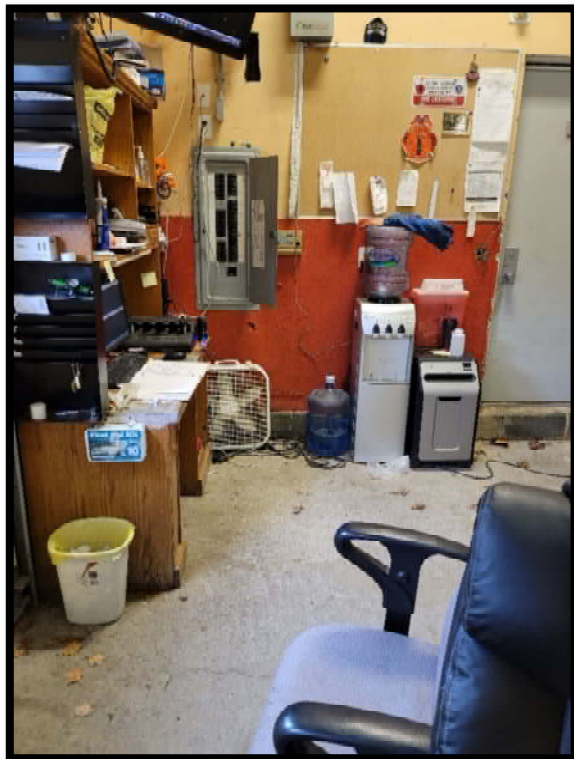
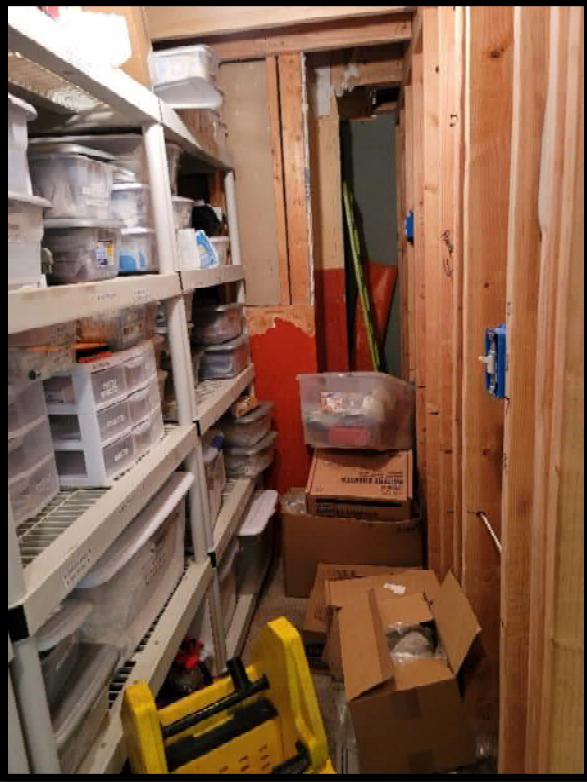
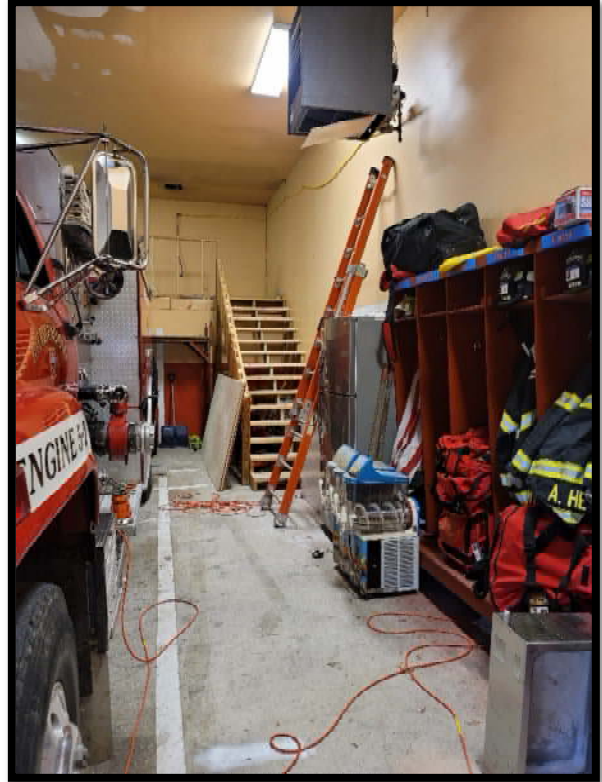
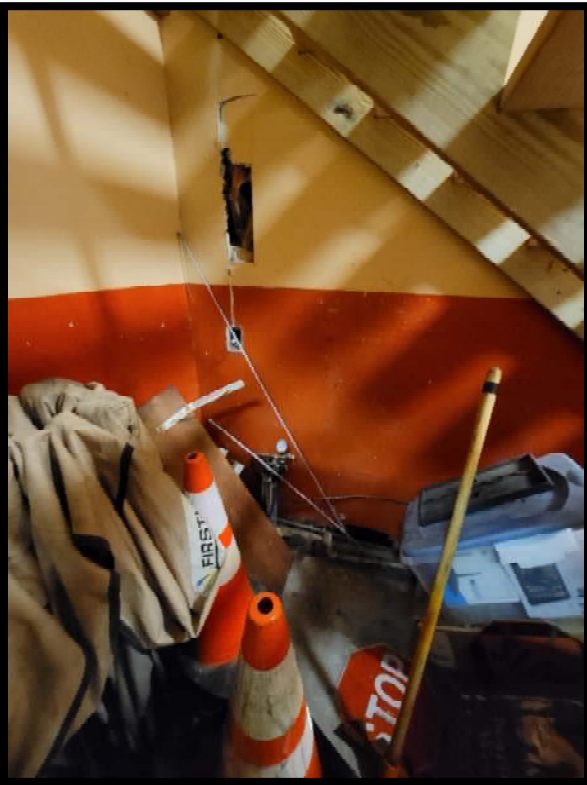
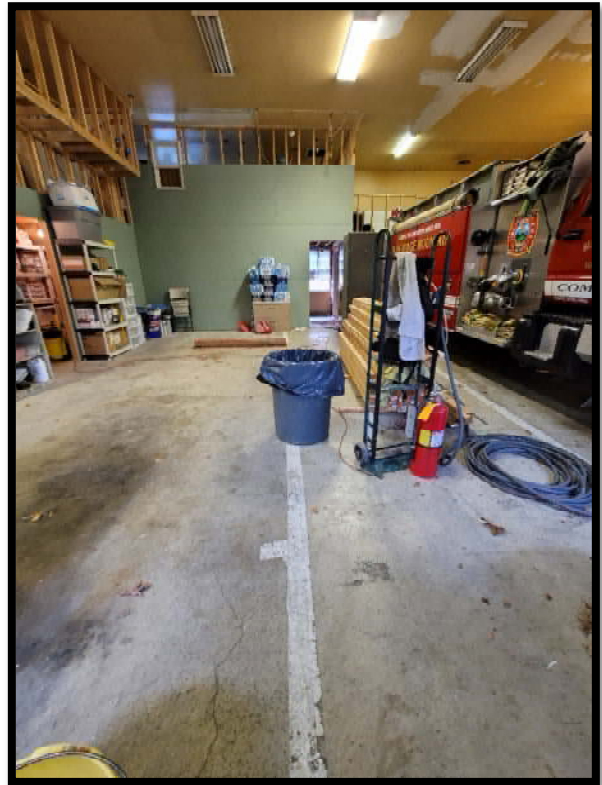
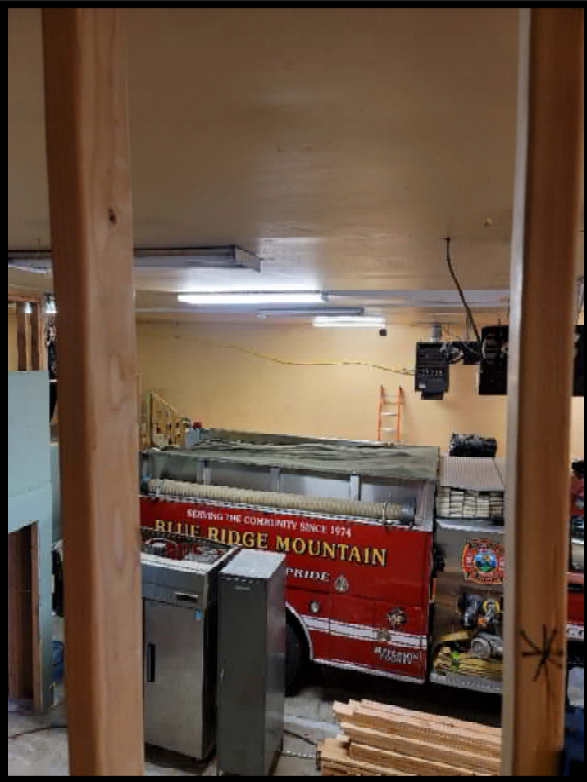
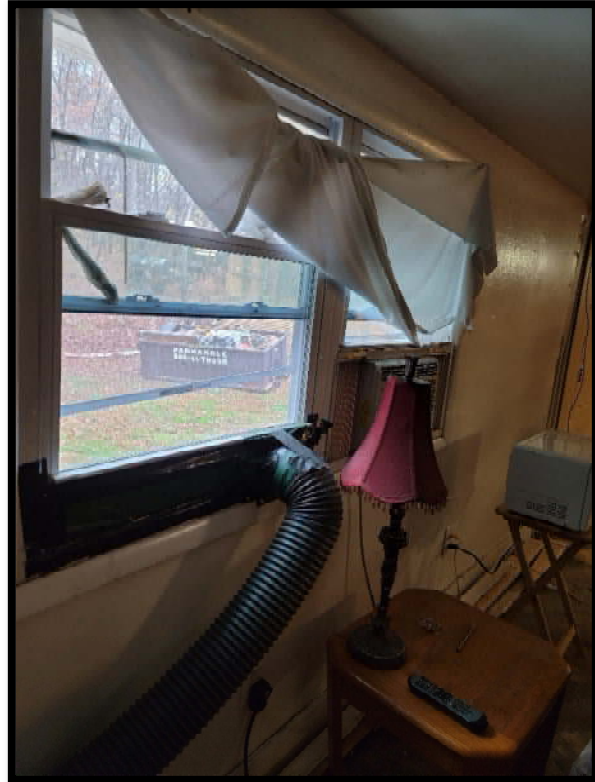
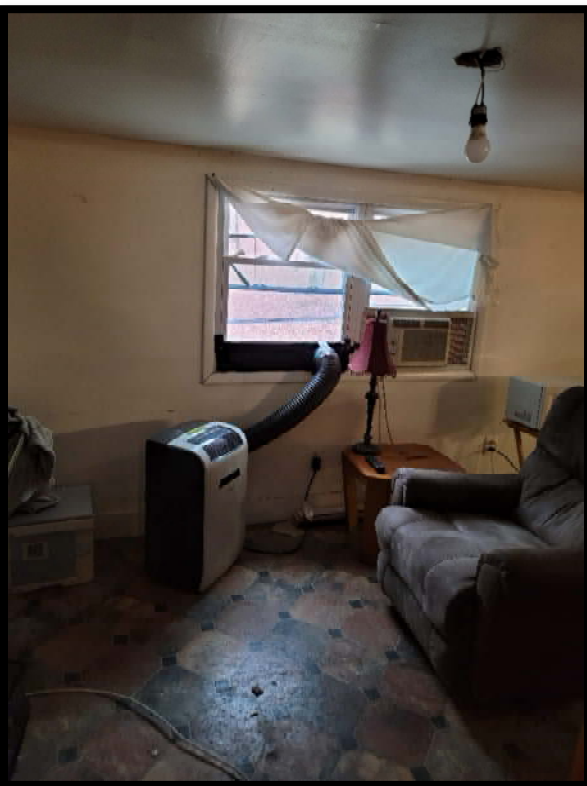
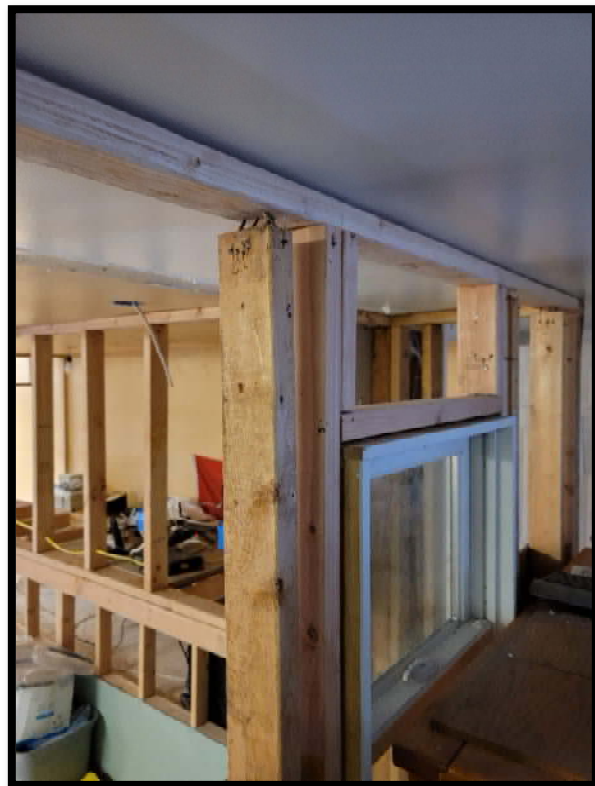
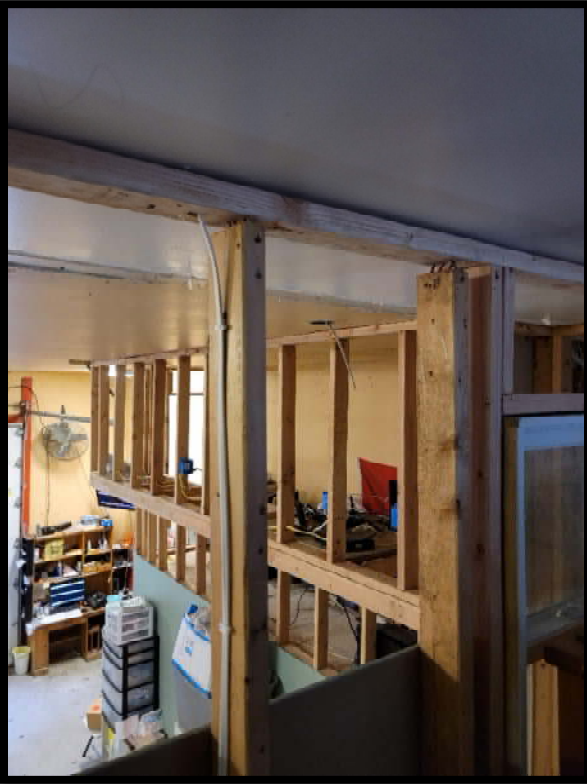
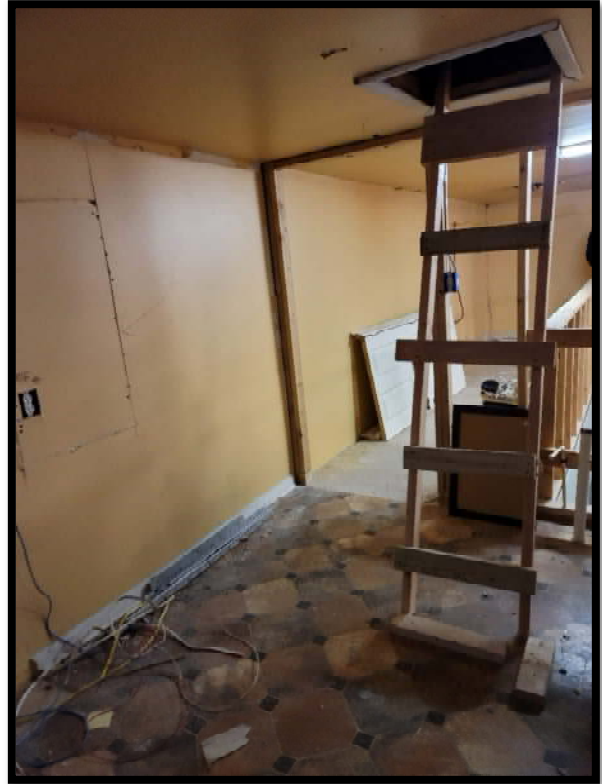
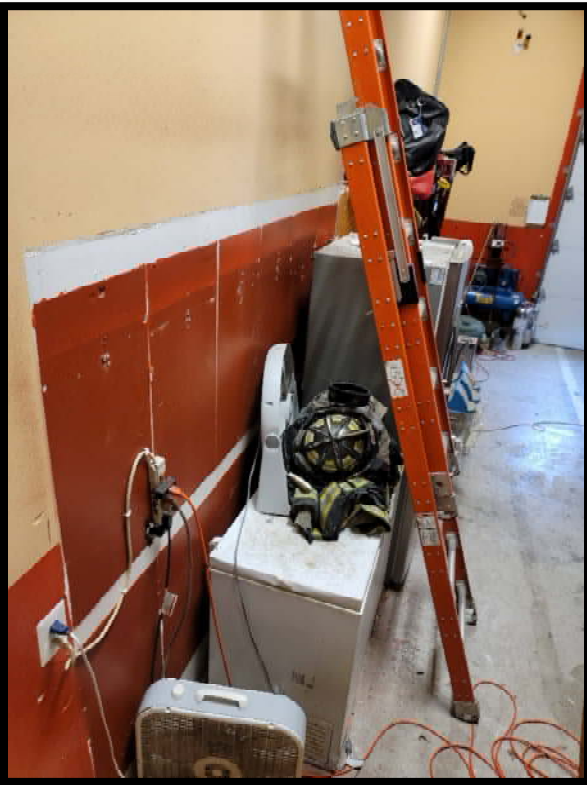
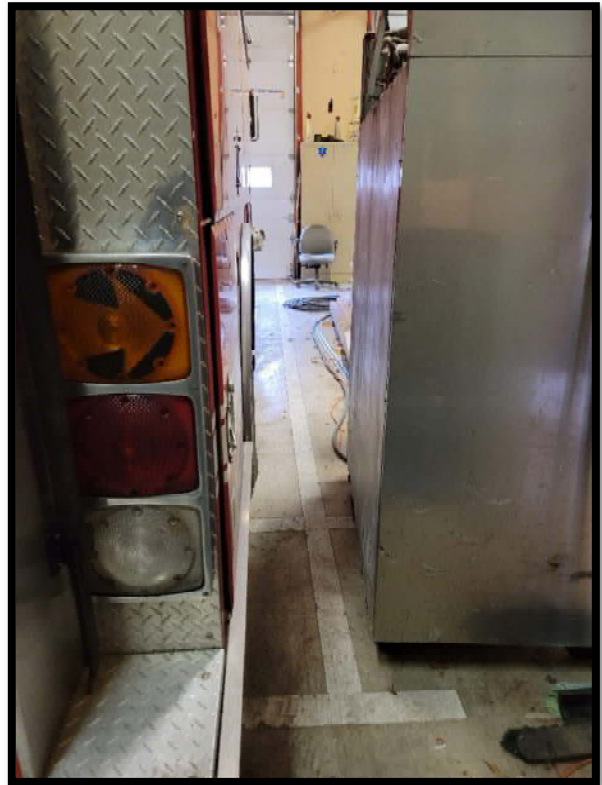
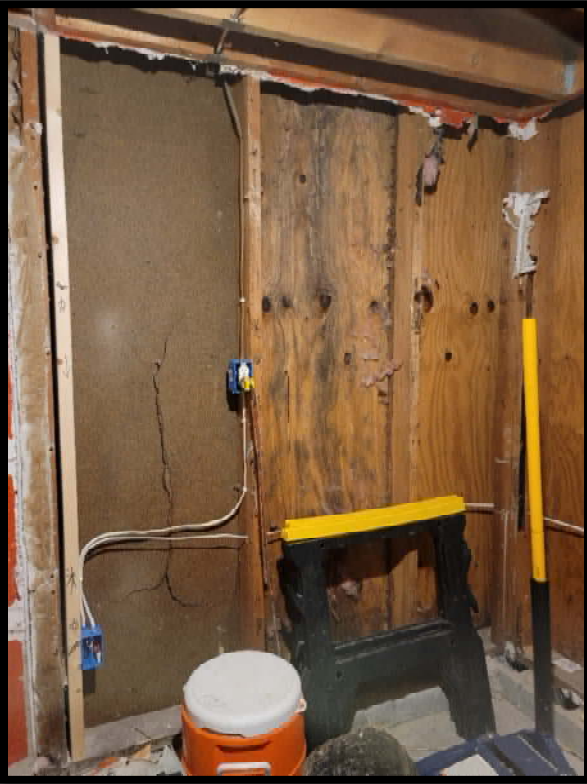
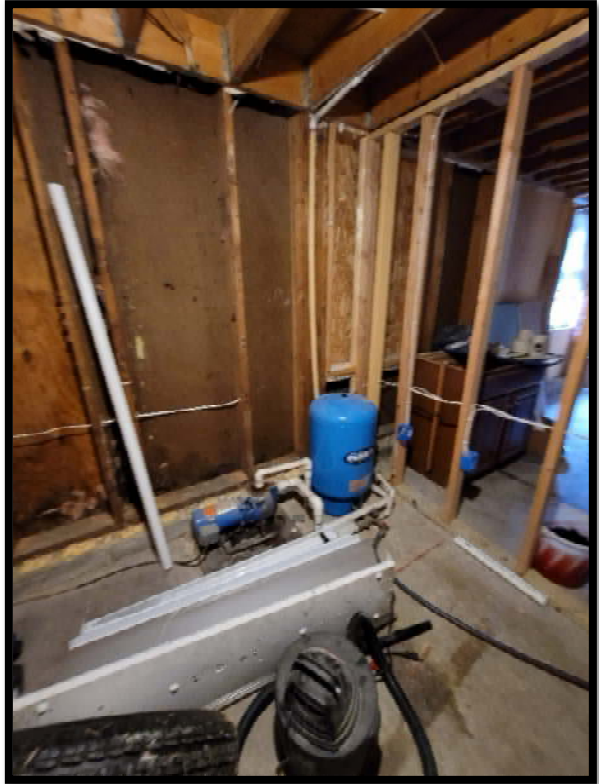
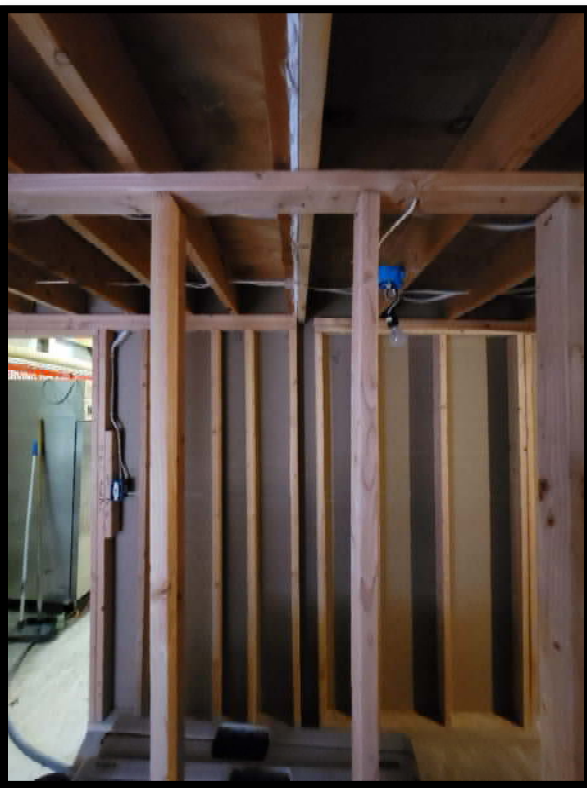
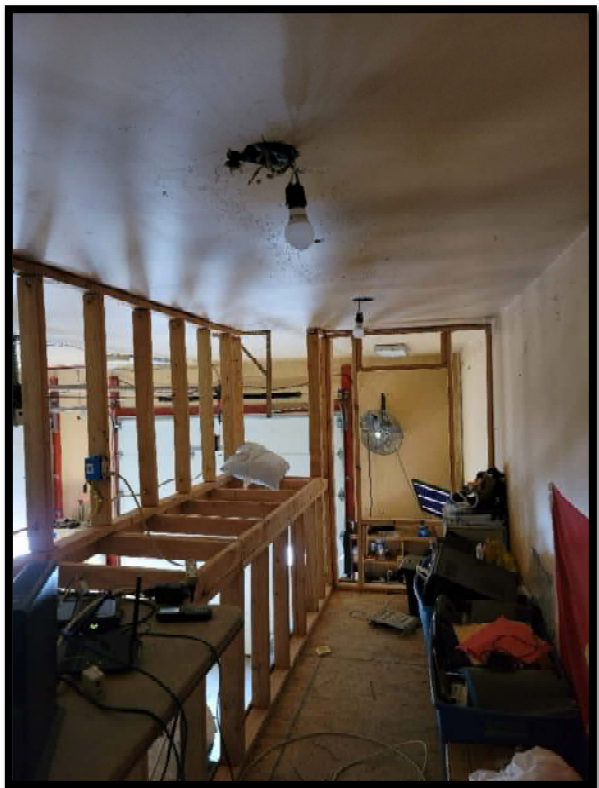
Attachment D

- a) Upon inspection, it was determined that the plans failed to meet building code.
 - b) Progress ceased.
 - (1) The state of the building is illustrated in photographs taken on November 12, 2020. [\[Attachment D\]](#)

- (a) A visit to the building on December 21 by Keyser and Burner revealed no notable changes.
 - (2) Construction remains unfinished with most framed walls uncovered, exposed wiring, holes, a stairway handrail that fails to meet safety requirements, construction material occupying space in the bay, a window on the back wall missing glass, wiring draped over the gear racks leading to a heater thermostat lying on a surface rather than mounted to the wall, etc.

Photographs of Sta 5-1 taken on November 12, 2020.

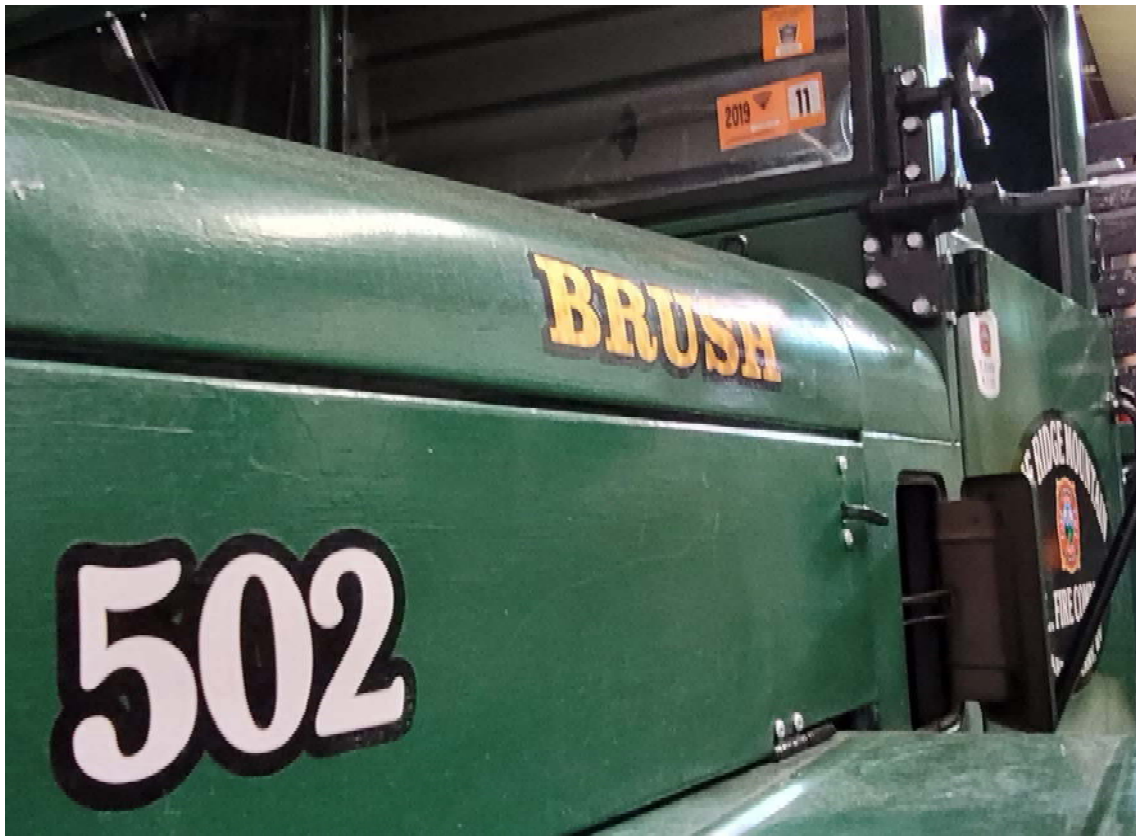
Attachment I

- Brush 502 fire pump leaks fuel. BRMVFC states it only leaks while sitting, not while running, and directs staff to only put fuel in it upon arrival at a fire and not to test it as part of the routine inspection for readiness. Additionally, the WVSP vehicle inspection expired over a year ago.

Expired state inspection on "Brush 502" since November of 2019. Photo taken Nov. 12, 2020

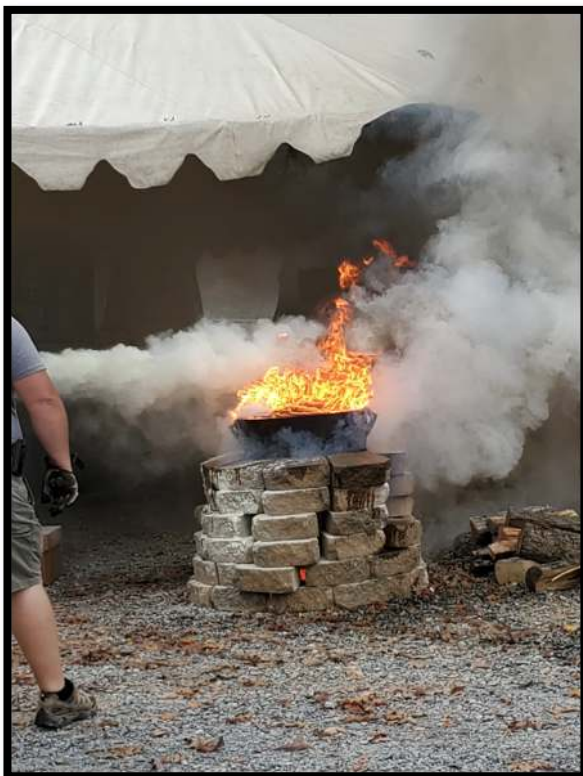
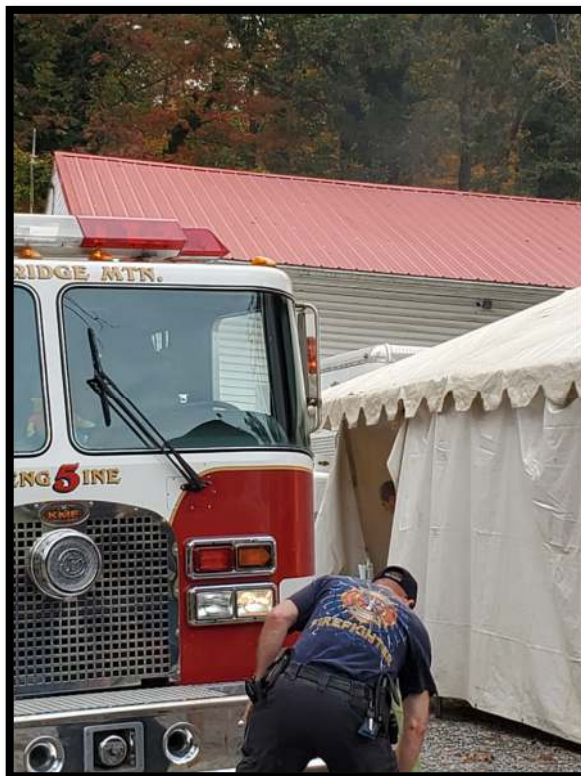
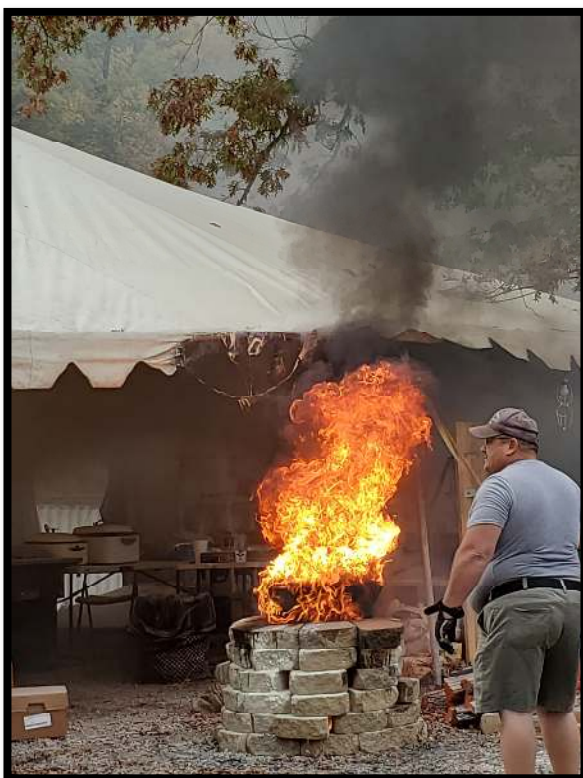
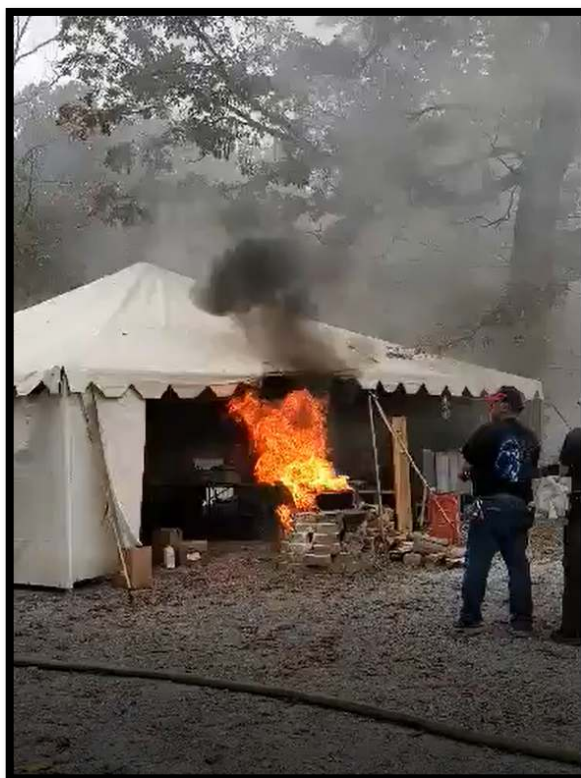
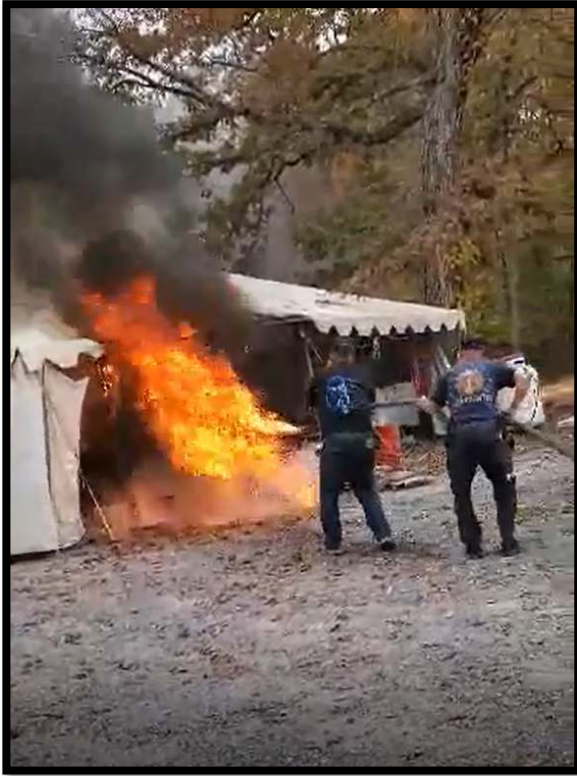
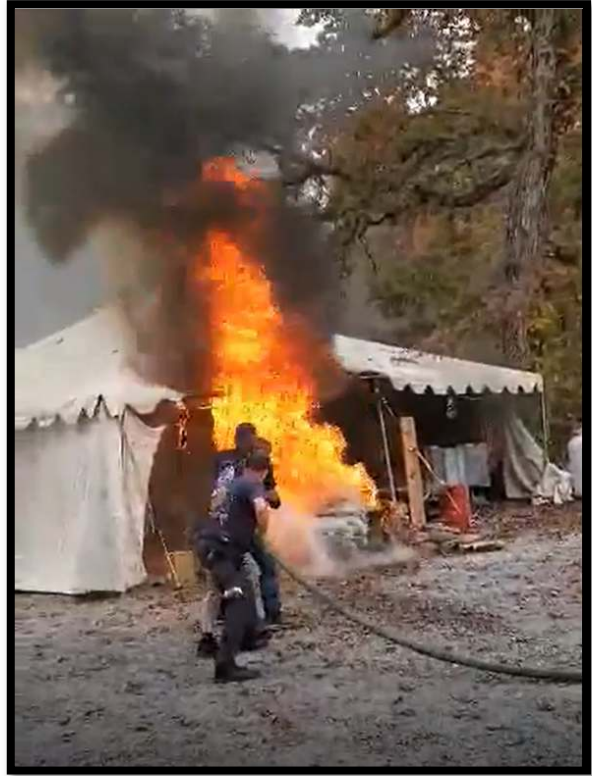
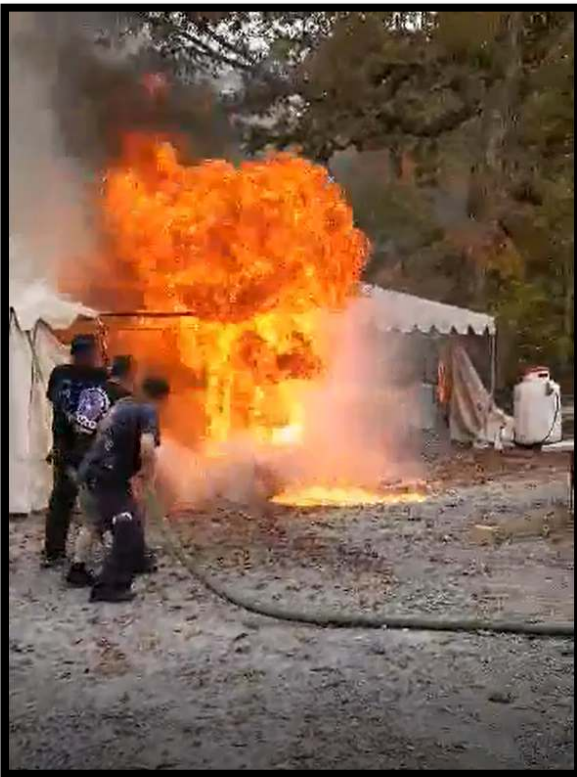
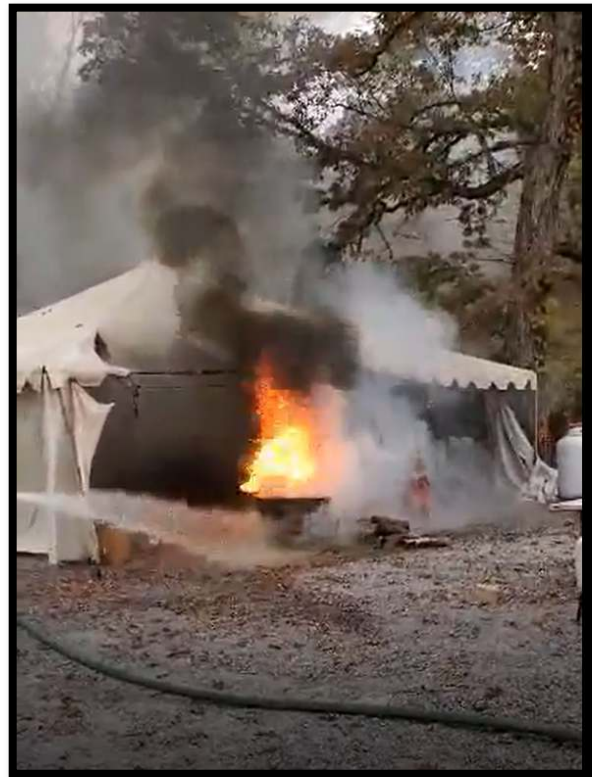
Attachment L

6. The management practices of BRMVFC cause concern regarding the safety of ESA personnel operating under BRMVFC leadership on emergency incidents.
 - A preventable grease fire erupted under a tent on BRMVFC property on October 24. A video recording shows BRMVFC firefighters, under the supervision of the fire chief, fighting the fire with water and without donning any personal protective equipment.

Photographs of the grease fire taken on October 24, 2020.
