Cross-section Paint Microscopy Report

Jefferson County Courthouse Exterior Paints Charles Town, West Virginia

Date: October 12, 2012

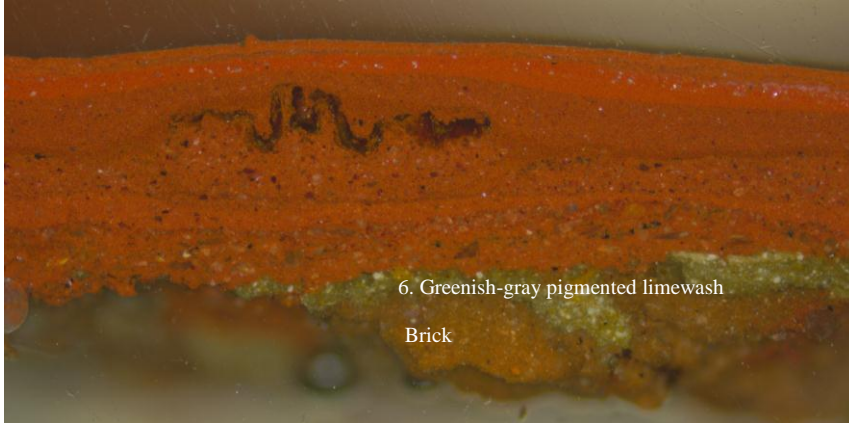
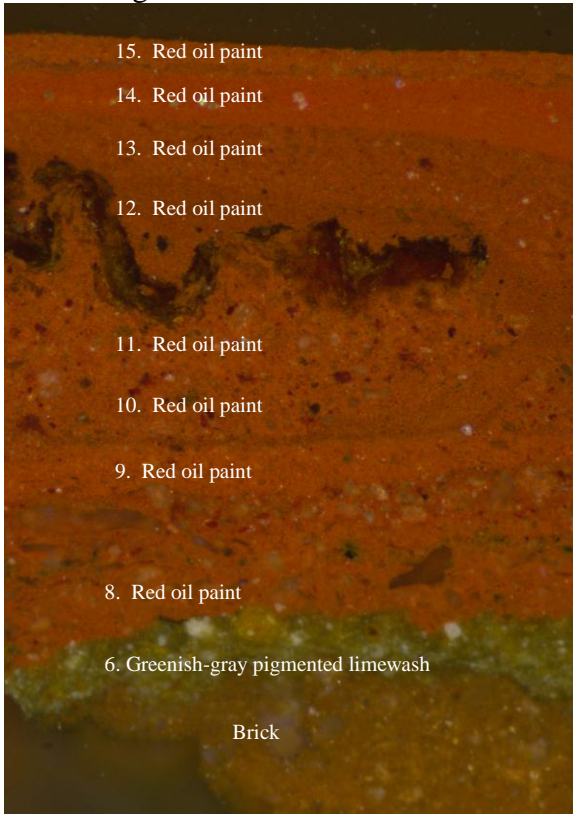
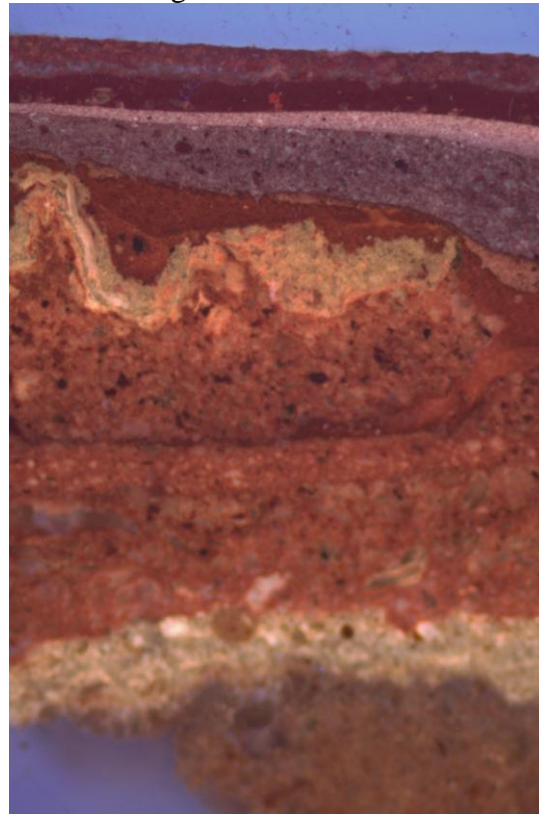
Sample 1. South elevation. Brick left of door, about 3-feet up, at peeling area, recent paint is thick and flexible.

The evidence in other cross-sections shows that in some areas the earliest paints are quite fragmentary. Sample 1, from an area of peeling paint on the south elevation, is missing generations 1 through 5, and retains remnants of the grayish-green limewash found in generation 6, followed by seven generations of dark red oil-based paints.

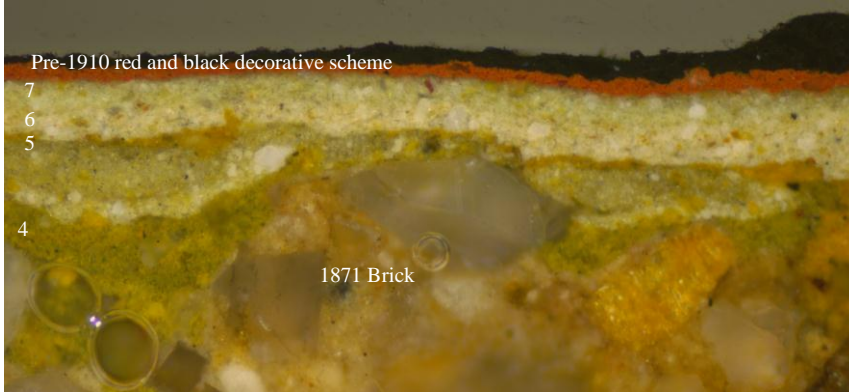
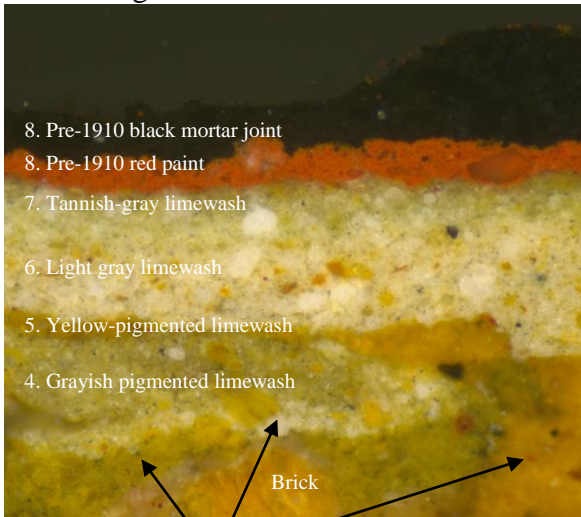
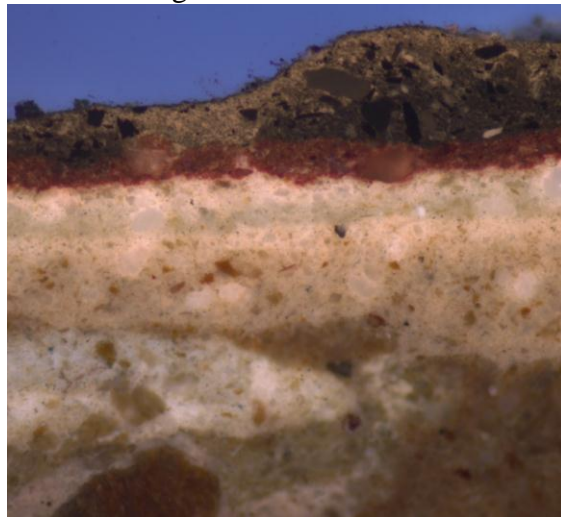
Sample 2. North elevation. Trapped brick just below gable level, enclosed by north addition, coating is red paint with joints picked out in black.

When the paint history in sample 2, taken from the upper section of the trapped wall at the north end of the 1837 building, is compared to the evidence in samples 3 and 4, it is apparent that the first coating is a grayish pigmented limewash that can be aligned with generation 4 in the samples from the south elevation. The paints found on the trapped north wall consist only of generations 4 through 8. Generation 8 is the red oil-based paint with black mortar joints that can still be seen on the trapped north wall of the original building. This is consistent with this upper section of north wall being constructed as part of the 1871-72 restoration and then trapped by the addition in 1910.

Later limewashes flowed into cracks in earlier coatings

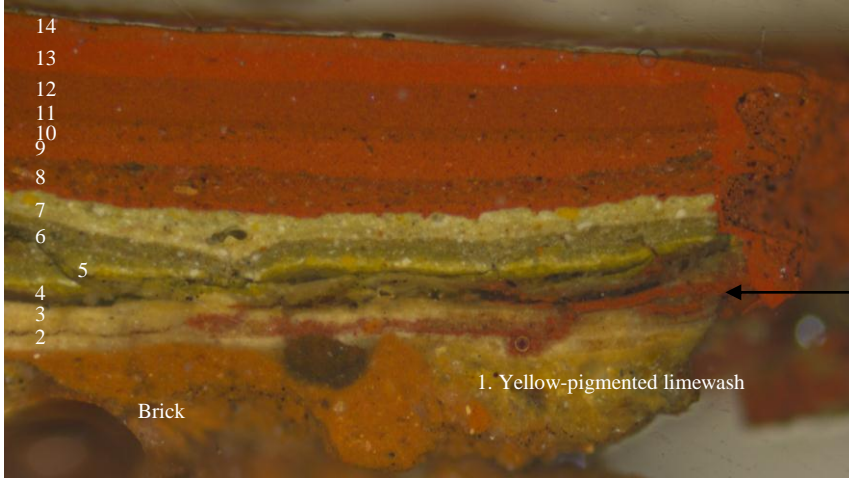
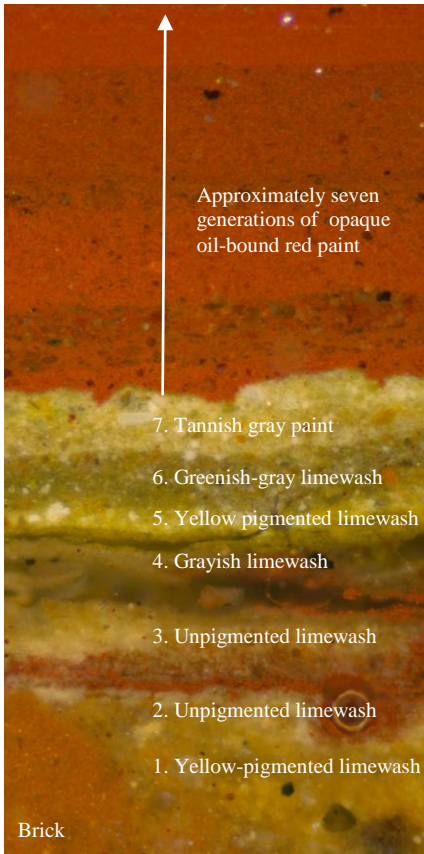
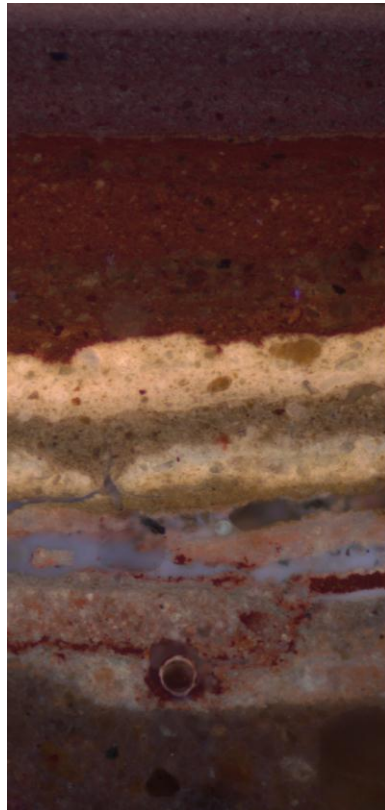
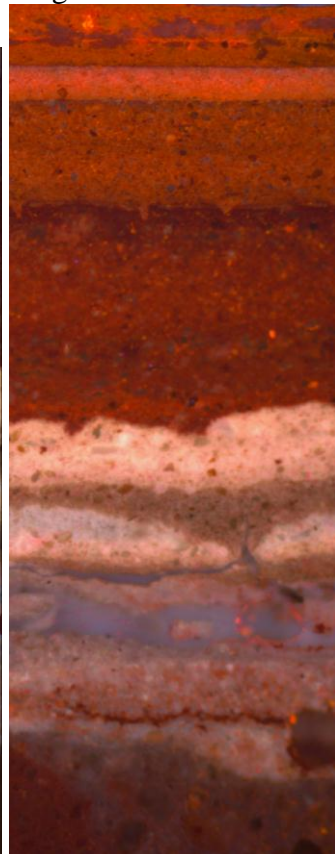
Sample 3. South elevation. Relatively intact painted brick above bronze plaque left of door.

The most complete paint sequence for the 1837 bricks was found in sample 3 from an intact painted area of brick on the south elevation. There are approximately fifteen generations of coatings, beginning with remnants of a chalky, slightly translucent, yellow-pigmented limewash directly on top of the brick. This is followed by two more unpigmented limewashes, and then a grayish pigmented limewash in generation 4. Generation 5 is a yellowish pigmented limewash, and generation 6 is a greenish-gray pigmented limewash. Generation 7, a tannish-gray paint, is the first opaque, oil-based paint in the paint stratigraphy. All the subsequent coatings are opaque oil-based paints that are similar shades of red. A comparable sequence of coatings was found in sample 4 from a mortar joint in an intact area of paint on the south elevation.

Later red paint flowed into cracks in early limewashes

UV Light & RHOB + for oils in generations 7-14

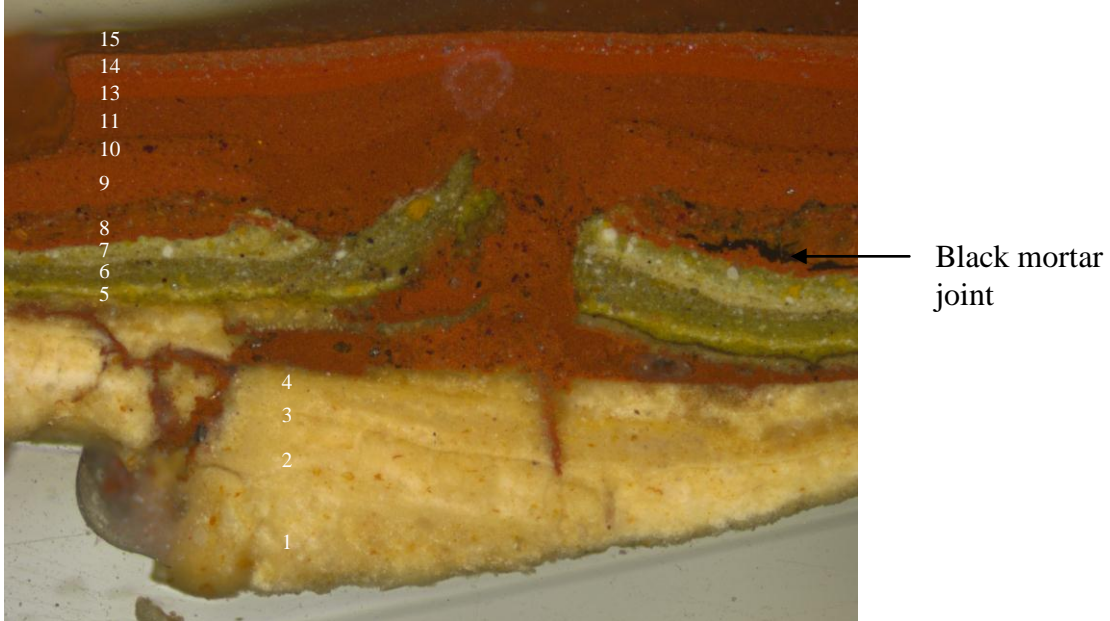
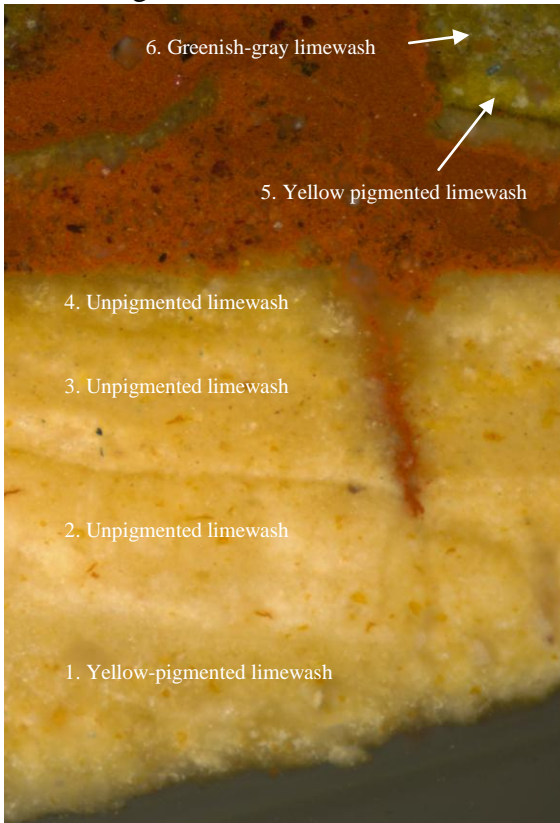
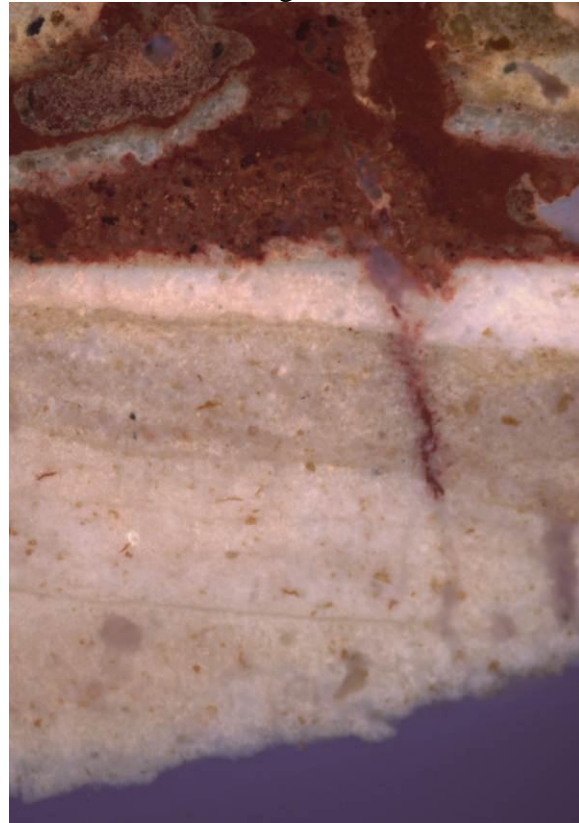
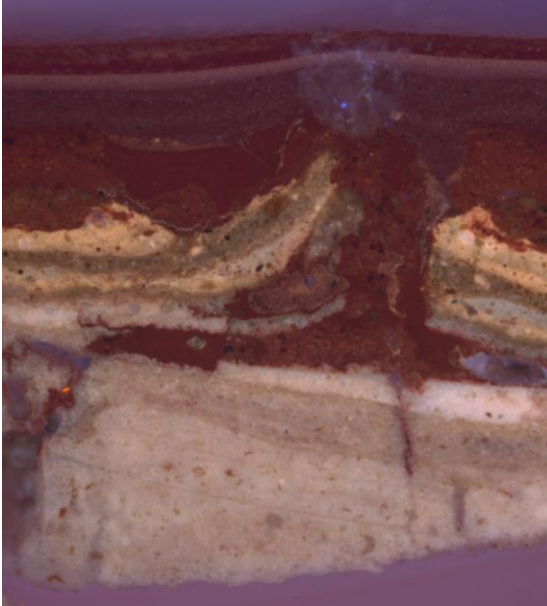
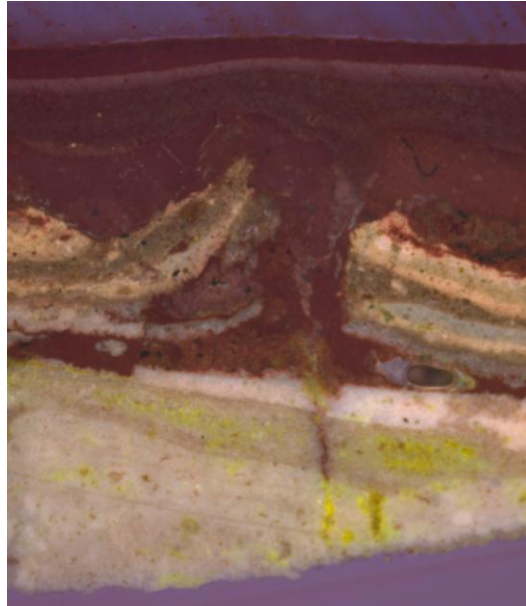
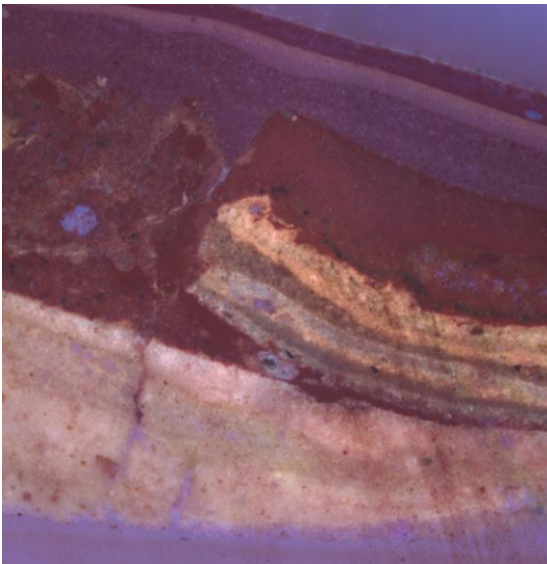
Sample 4. South elevation. Relatively intact painted mortar above bronze plaque, mortar is quite soft.

UV Light & FITC for proteins 40X
Weak + reactions for proteins in generations 1-4

UV Light & TTC for carbohydrates 40X
Weak+ reactions for carbohydrates in generations 8-15

UV Light & RHOB for oils 40X
Strong + reactions for oils in generations 8-15

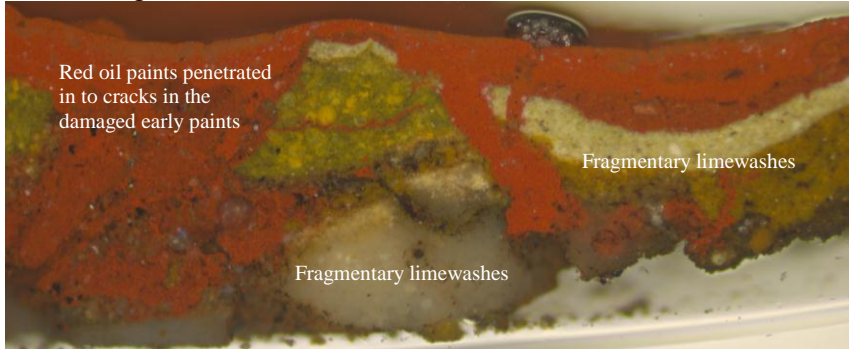
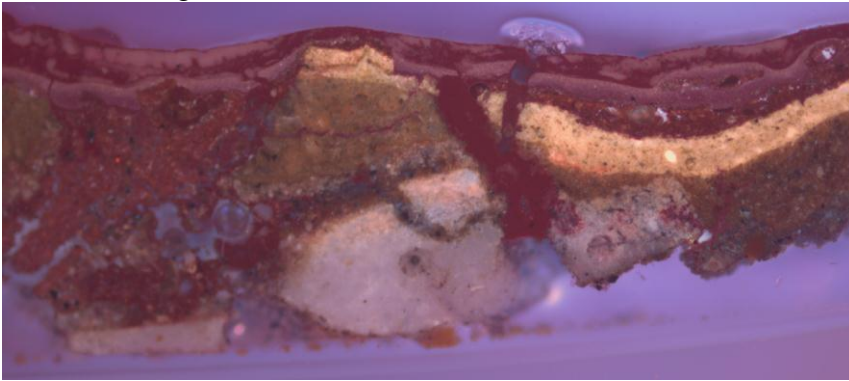
Sample 7. West elevation. Brick below north window, about 5-feet up, area of incipient paint failure.

Sample 7, from a badly peeling area of brick on the west elevation, retains only remnants of the early limewashes, followed by the most two most recent oil-based paints. By comparison, the coatings in sample 8, from a stable area of painted brick on the west elevation, consist only of the most recent seven generations of oil-based deep red paint. There are no limewashes in this cross-section, which may be one reason that the oil-based paints are so well-adhered in this area.

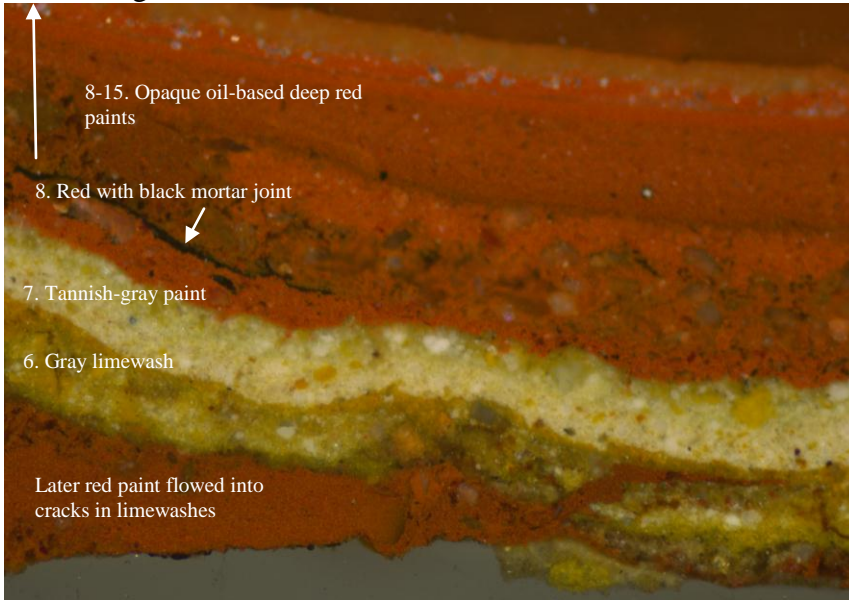
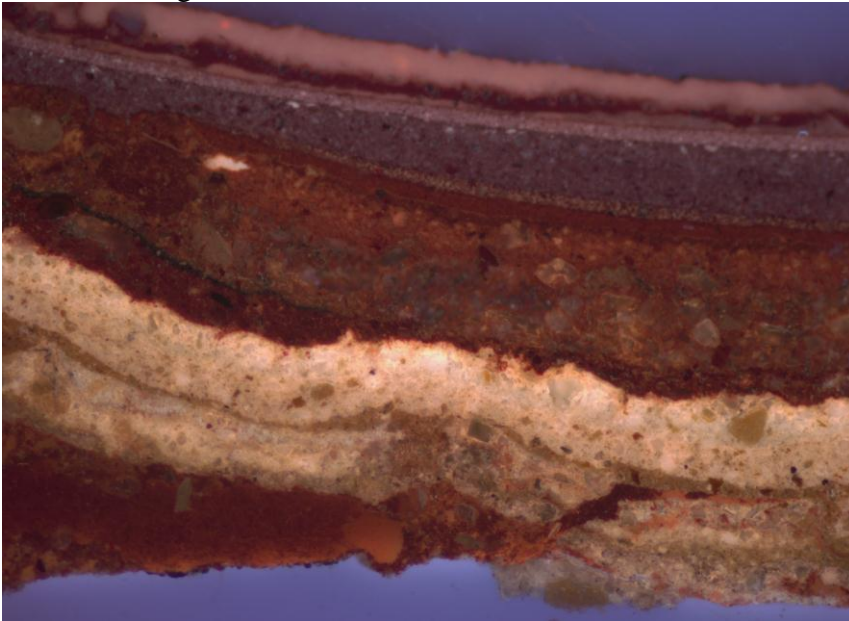
Sample 11. East elevation. Cleaving paint on top of mortar joint below north window.

The brick and mortar surfaces on the east elevation (samples 10 and 11) retain a few of the early limewashes. But in sample 11, taken from a mortar joint where the paints are actively flaking, the later red paints have flowed into cracks between the damaged layers of the generation 6 and 7 limewashes. The absence of the earliest limewashes suggests that this area has had flaking problems for many years. The stratigraphy of coatings found on the most intact areas of brick and mortar is shown in the chart below.

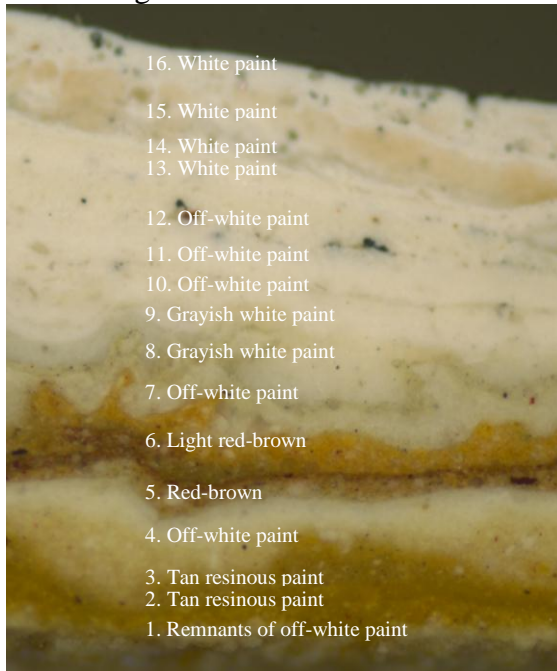
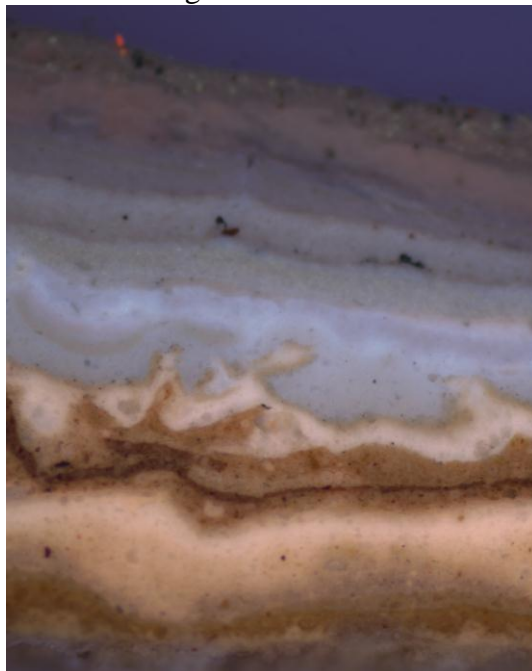
Sample 5. South elevation. West window, west architrave, 5-feet up at loss, for trim paints.

In this cross-section there are remnants of off-white paint remaining on top of the wood substrate, which may date to 1837. Generations 2 and 3 are tan paints with resinous components which would have made them glossier and more durable than traditional white lead-based oilbound paints. Generation 4 is off-white, followed by two red-brown paints in generations 5 and 6. All the subsequent paint layers are variations of cream color and off-white. The most recent bright white paints are considerably brighter and cooler in color than the earliest off-white coatings.

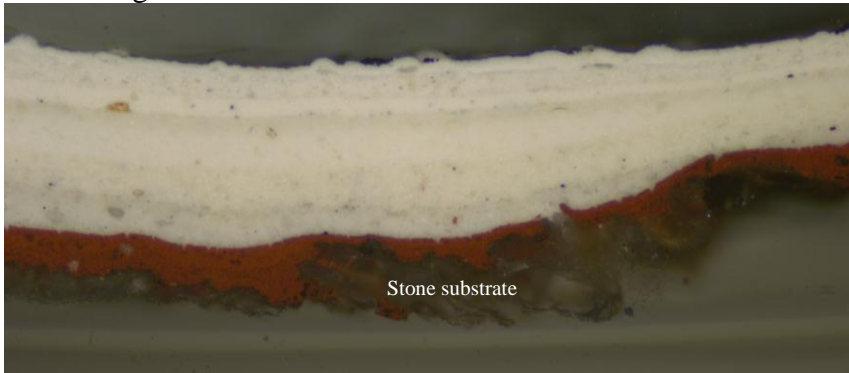
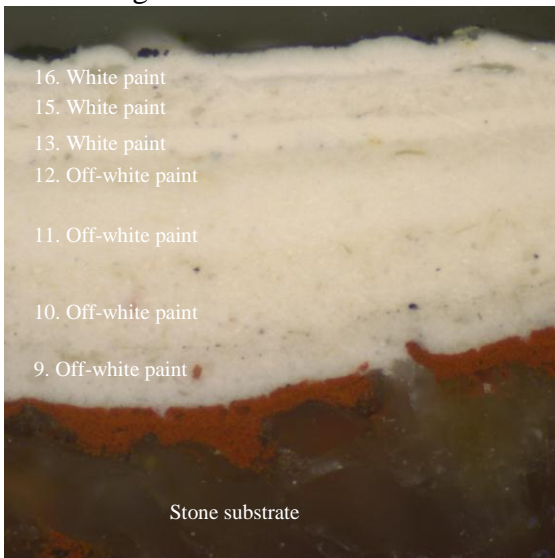
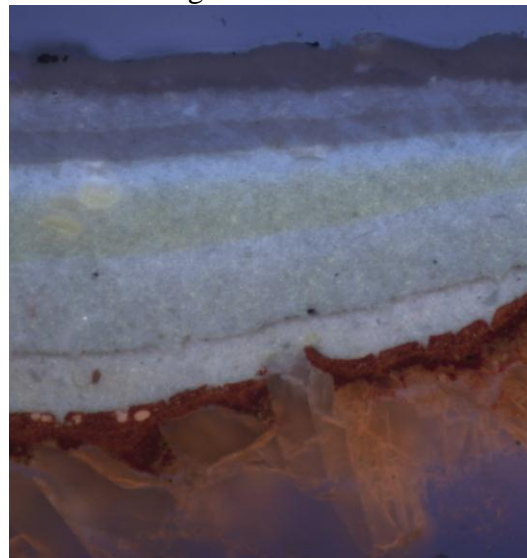
Sample 9. West elevation. North window, trim paint on underside of stone sill, right corner.

When the paints in sample 9 from the underside of the stone window sill are compared to sample 5, it appears that the first paint on the sill is a deep red that may be an overlap from the brick body color. This is followed by off-white and white paints that can be aligned with generations 9 through 16. The comparative evidence suggests that there is a long history of cream-colored or off-white paint on the window trim, and certainly by the 1910 addition the window trim was consistently painted off-white.

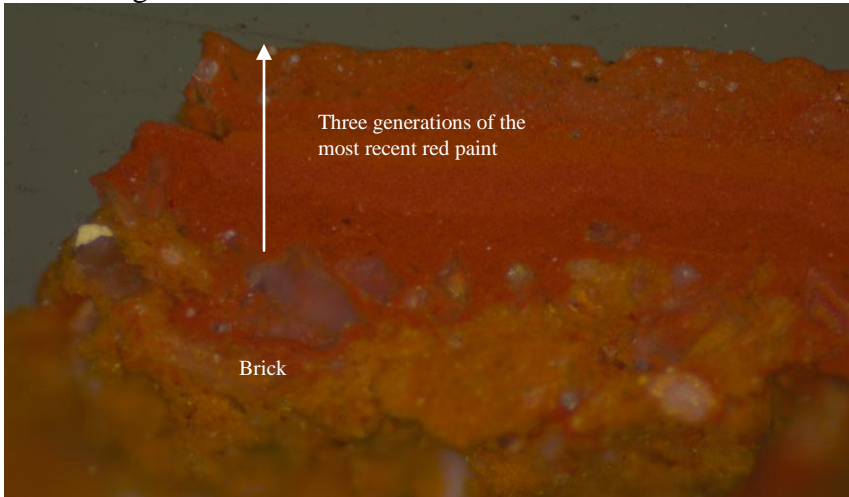
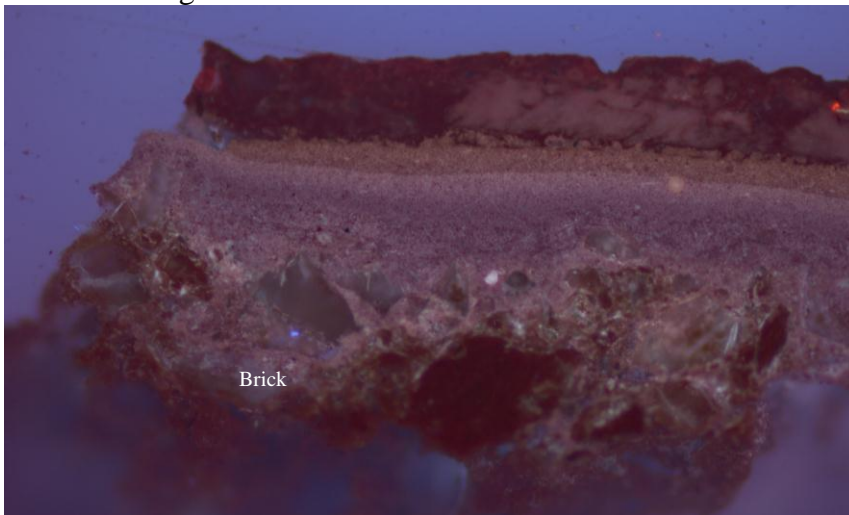
Sample 6. South elevation. Stable paint on brick of one-story east addition, about 5-feet up, near join with original building.

One area of painted brick on the most recent addition to the east of the Courthouse was sampled for comparison with the historic painted surfaces. This cross-section shows that one reason the red paint is so well-adhered and stable is that the first paint layer penetrated deeply into the uneven surface of the brick, creating a strong mechanical bond. The next two red paints are smooth and unweathered finish coats. There are no priming layers in this cross-section.
