Cross-section Paint Microscopy Report

Jefferson County Courthouse Exterior Paints Charles Town, West Virginia

Date: October 12, 2012

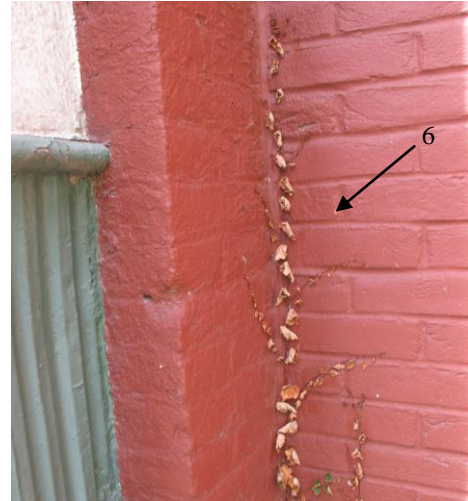
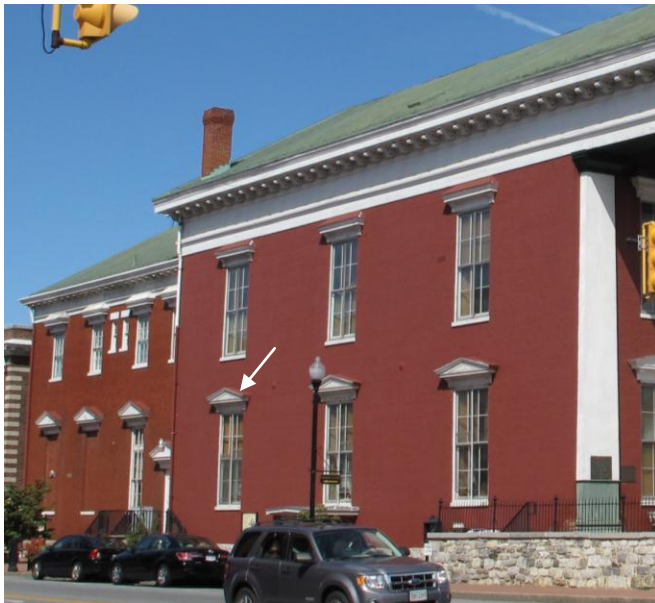
West Elevation North Window

7. Brick below north window, about 5-feet up, area of incipient paint failure.
8. Brick below north window, about 6-feet up, area where the paints are well-adhered to the brick.
9. North window, trim paint on underside of stone sill, right corner.

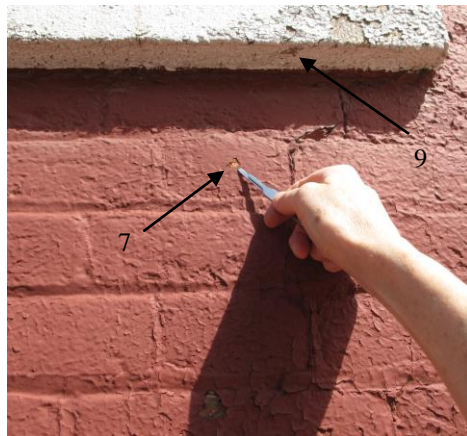
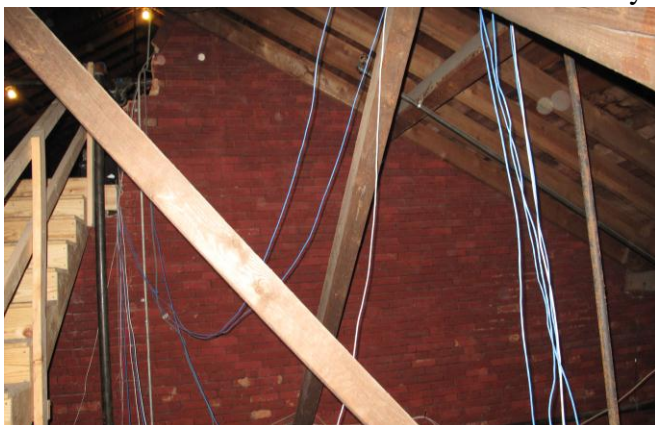
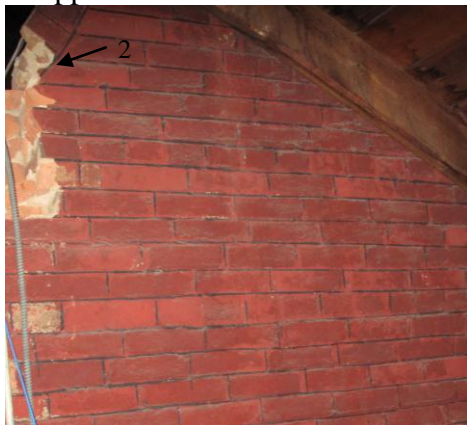
Painted Bricks and Mortar Joints on Second Story of Trapped North Elevation

2. Trapped brick just below gable level, enclosed by north addition, coating is red paint with joints picked out in black.

When the paint history in sample 2, taken from the upper section of the trapped wall at the north end of the 1837 building, is compared to the evidence in samples 3 and 4, it is apparent that the first coating is a grayish pigmented limewash that can be aligned with generation 4 in the samples from the south elevation. The paints found on the trapped north wall consist only of generations 4 through 8. Generation 8 is the red oil-based paint with black mortar joints that can still be seen on the trapped north wall of the original building. This is consistent with this upper section of north wall being constructed as part of the 1871-72 restoration and then trapped by the addition in 1910.

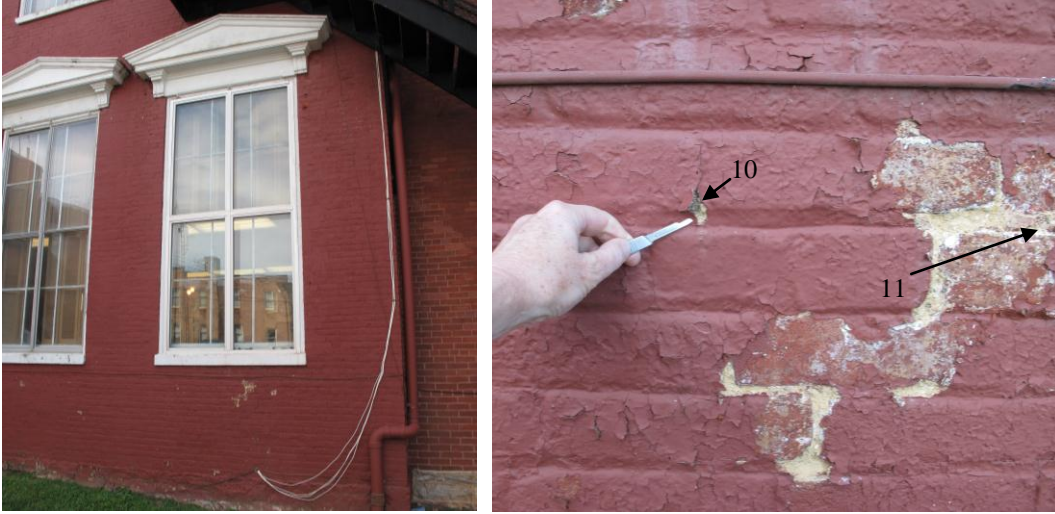
East Elevation

10. Stable paint on top of mortar joint below north window.
11. Cleaving paint on top of mortar joint below north window.

The brick and mortar surfaces on the east elevation (samples 10 and 11) retain a few of the early limewashes. But in sample 11, taken from a mortar joint where the paints are actively flaking, the later red paints have flowed into cracks between the damaged layers of the generation 6 and 7 limewashes. The absence of the earliest limewashes suggests that this area has had flaking problems for many years. The stratigraphy of coatings found on the most intact areas of brick and mortar is shown in the chart below.

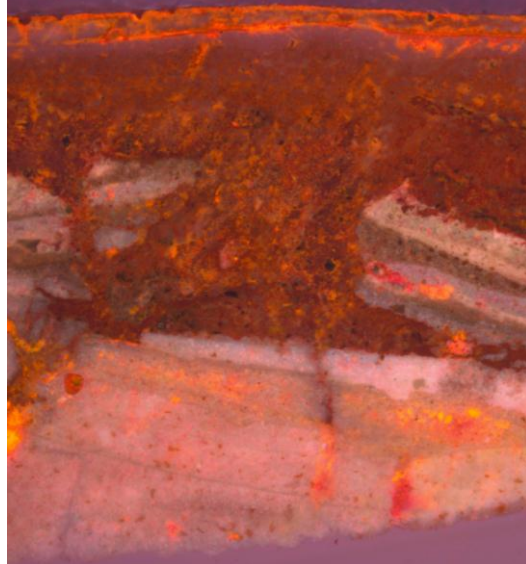
UV Light & RHOB for oils 40X
Strong + reactions for oils in generations 8-15

Sample 7. West elevation. Brick below north window, about 5-feet up, area of incipient paint failure.

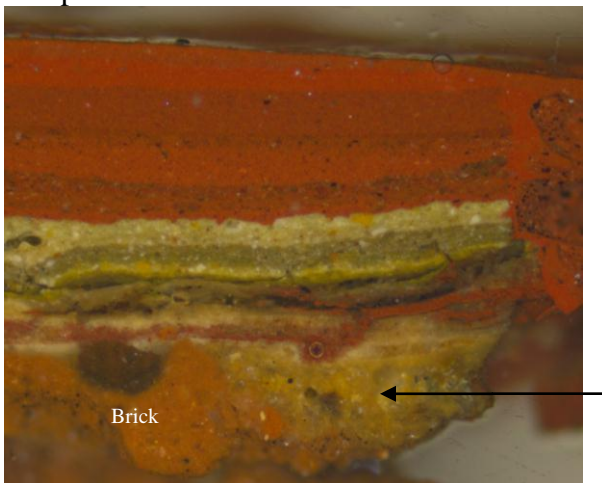
Sample 3

The degraded dull yellow-pigmented limewash was matched by eye at 30X magnification under a color-corrected light source to the Munsell Book of standards and it was measured with a Minolta CR 241 colorimeter/microscope. The swatch for 2165-10 is an excellent visual match to the best surviving areas of this original pigmented limewash. The evidence in the cross-section and the uncast samples suggest this paint was originally chalky and could be reproduced in a flat gloss level.

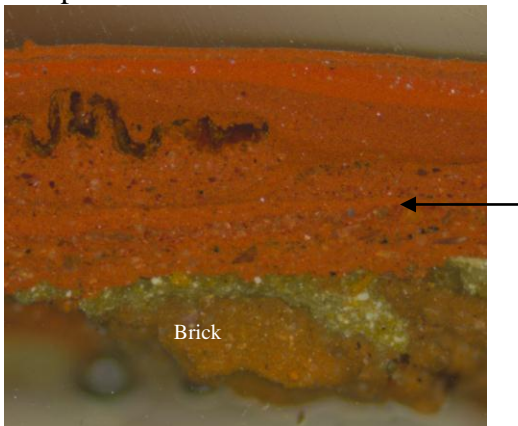
Sample 1

The deep red layer was matched by eye at 30X magnification under a color-corrected light source to the Munsell Book of standards and it was measured with a Minolta CR 241 colorimeter/microscope. The commercial swatch is just slightly darker (the L value) and slightly redder (the a value) than the best preserved areas of the aged deep red paint applied to the 1910 addition. The swatch for 2084-10 is an excellent visual match to the best surviving areas of this deep red exterior paint. The evidence in the cross-section and the uncast samples suggest this paint was originally not particularly glossy and could be reproduced in eggshell gloss level coating.

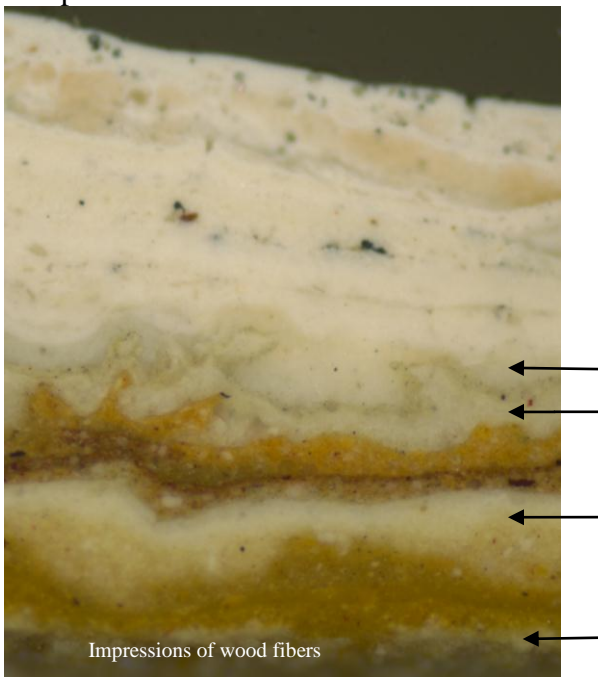
Sample 5

There are at least four generations of paint on the window trim that are good visual matches with this traditional white lead and linseed oil-based paint color. The swatch for OC-40 is a good reference color for this type of traditional exterior trim paint. The evidence in the cross-section and the uncast samples suggest this paint was originally moderately glossy and could be reproduced in a semi-gloss level coating.
